METALS HANDBOOK

VOL. 9
FRACTOGRAPHY AND ATLAS OF FRACTOGRAPHY

8th EDITION

Fractography and Atlas of Fractographs

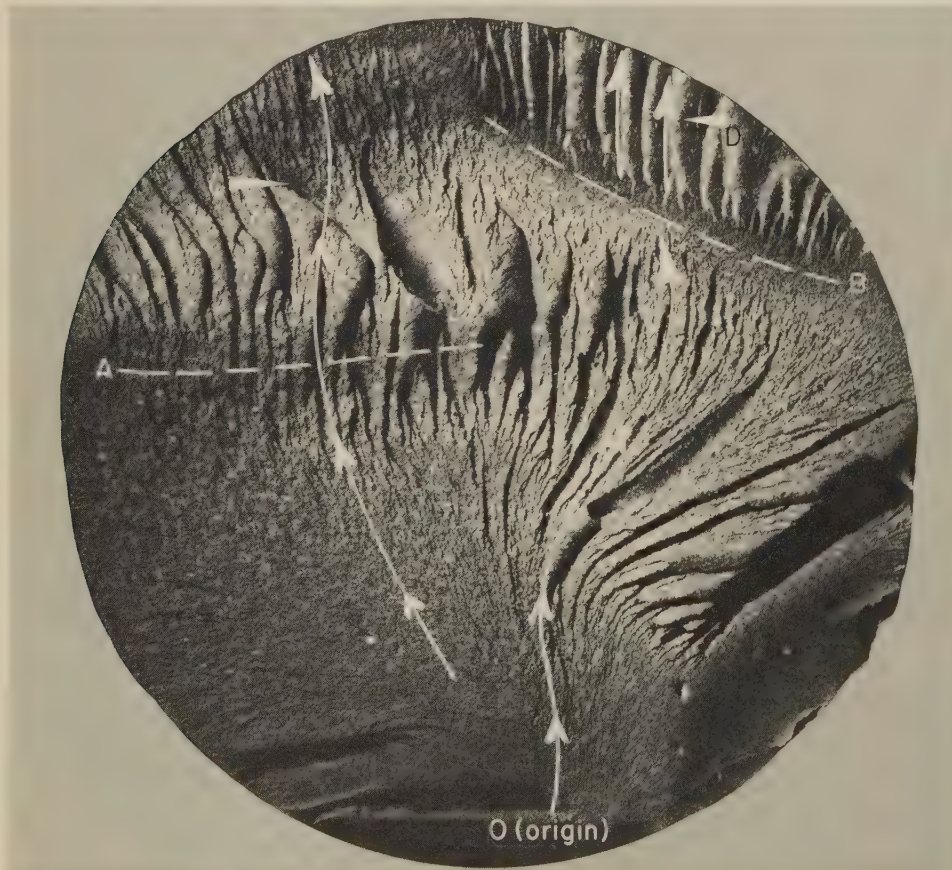
Light fractograph

3×

Location of Origins in Impact-Overload Fractures. Figure 18 shows the fracture of a 12% Cr steel bar that was notched and then struck with a hammer. Two blows were necessary to complete the fracture. The fracture marks are radial. They may be traced downward to a common intersection. Also present are crack arrests, one at A and a second at B, where fracture progress came to a complete halt before the second blow was struck. The arrest marks are parallel to the crack front, and lines drawn normal to them should intersect at or near the origin. The contours of the final fracture marks, at C and D, also point to the general location of the beginning of fracture.

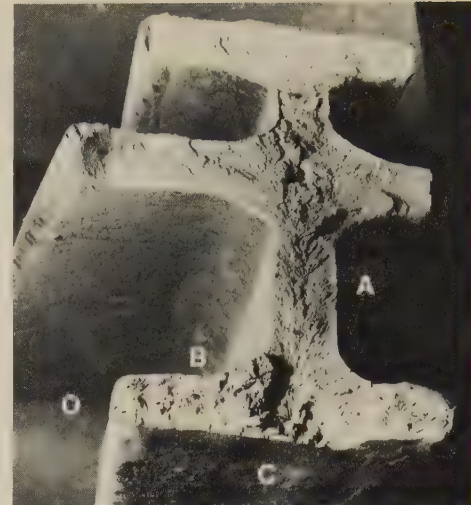
Light fractograph

0.4×

arrest fronts labeled A and B; and by projecting the tangents to the final radial marks at C and D toward the bottom. The crack came to a full stop at B with the first hammer blow and resumed motion at the second hammer blow.

Fig. 18. Locating the origin in an impact fracture, produced by two hammer blows, in a notched bar of 12% Cr steel

In Fig. 19, a fracture in a cast steel frame bar, chevron patterns (perhaps most distinct at A) point downward toward the bottom flange. Within the flange are less distinct chevron patterns (at B) suggesting that the crack origin

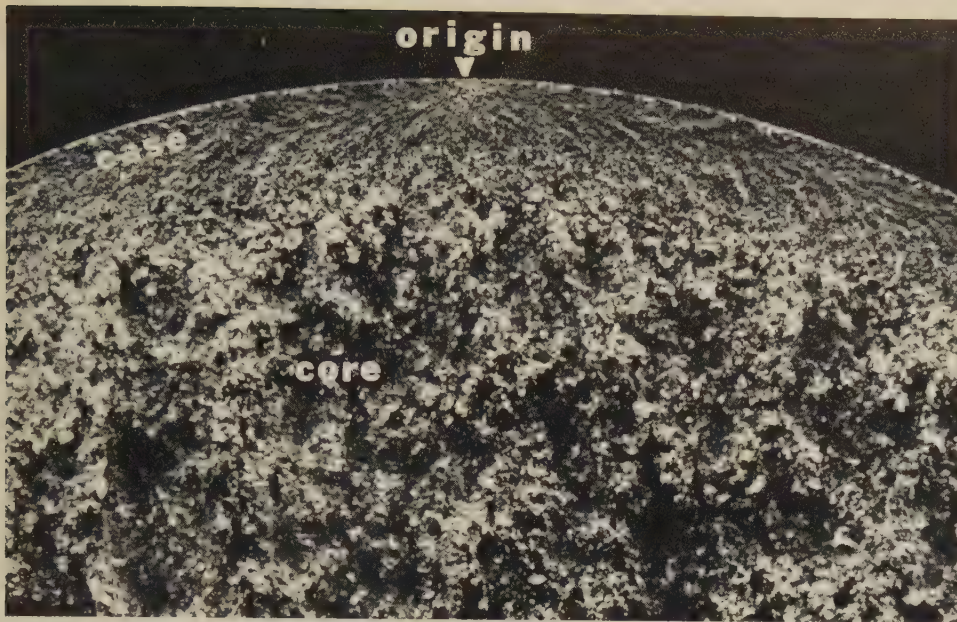
Fig. 20. Light fractograph showing a fracture surface of a carburized shaft of 8620 steel broken in bending by a dynamic single overload. The region of small facets is the crack origin. The chevron patterns in the case point toward the origin. Rupture in the core is known to be dimpled.

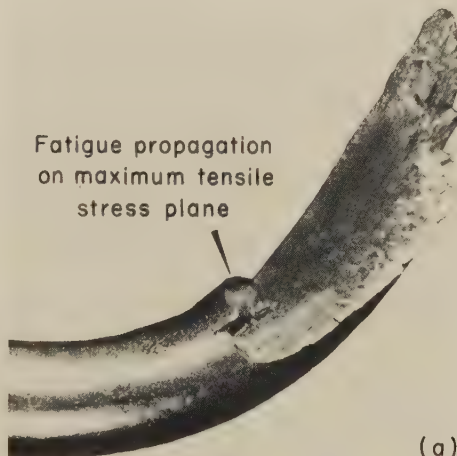
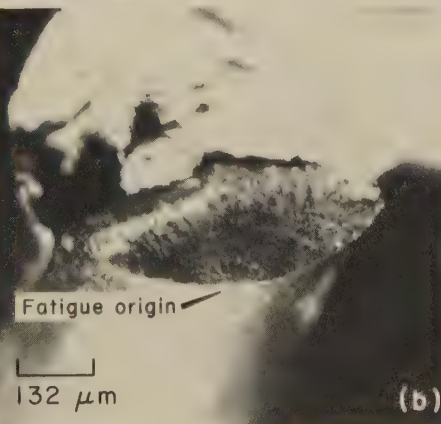
Light fractographs 22.5× (a); 76× (b)

The fatigue crack propagated in the plane of maximum tensile stress in a wire section that was loaded primarily in torsion. The higher-magnification view at bottom displays fine beach marks that are concentric with a tiny longitudinal step (not discernible in this view) that was the crack origin.

Fig. 23. Locating the origin of a torsional-fatigue fracture in a high-hardness steel music wire spring

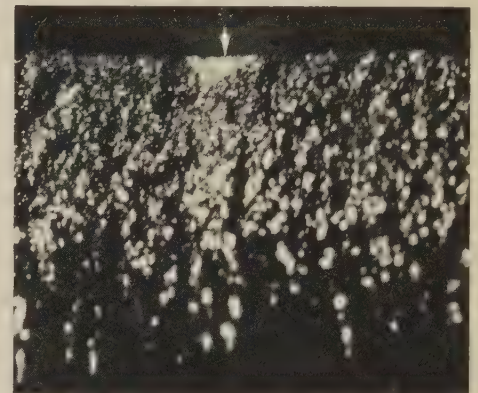
Light fractograph 40×
A very small fatigue-crack region (at arrow) is surrounded by a finely faceted region of final, fast fracture in the case. Fracture of the tooth took place after about 20,000 cycles. The fatigue-crack region had a slightly different orientation than the surrounding fast-fracture region; this condition, and the extreme care taken in getting proper lighting, resulted in the exceptionally good contrast between the two regions.

Fig. 24. Origin of fracture at fatigue-crack region at the surface of a carburized alloy steel gear tooth. Case hardness, Rockwell C 63; core hardness, Rockwell C 36.

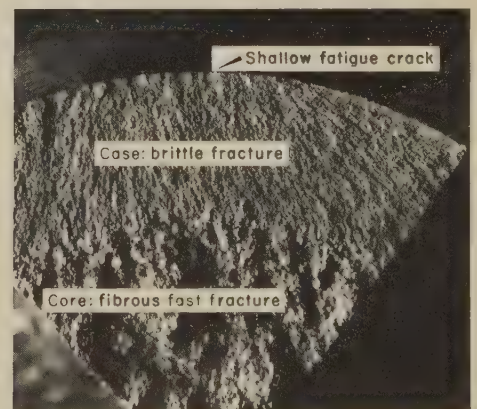
Light fractograph 31/2×
Fig. 25. Fracture surface of an induction-hardened shaft of medium-carbon steel showing a shallow fatigue crack at the outer rim that propagated from many origins. Fracture was of the single-overload type through the remainder of the case and the core.

are multiple crack origins, as in Fig. 25, the fatigue-crack regions may have many jagged steps, due to the linking of adjacent smooth-textured fatigue cracks that have slightly different orientations. The fatigue-crack regions usually have radial-type marks that converge at the origins.

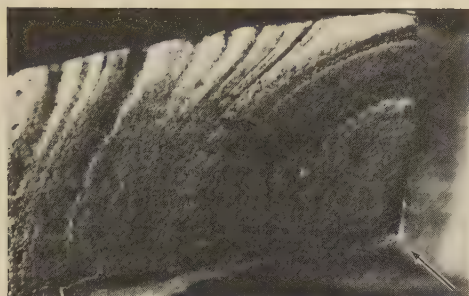
Light fractograph 5×
A line drawn perpendicular to the beach marks, within the region in which they have not yet reached the upper surface, will show that the lower right corner (arrow) is the site of the origin.

Fig. 26. Use of beach marks to locate origin of fatigue fracture in a 4340 steel socket

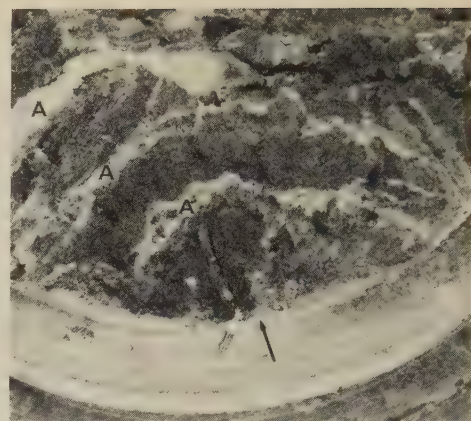
Light fractograph 4×
Fig. 27. Use of crack-arrest lines (A) to locate origin of a stress-corrosion fracture in a stressed manganese bronze bolt exposed to water. The arrest lines are roughly concentric about the origin (at arrow).

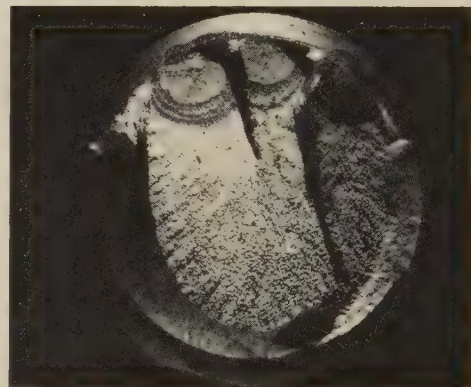
Light fractograph 2.8×
Steel hardness was Rockwell C 50. Fracture was produced under a static load with distilled water as the corrodent. Rings of corrosion product surround the three crack origins. The rings are beach marks, but not a result of fatigue.

Fig. 28. Multiple origins in a stress-corrosion fracture in a maraging steel stud

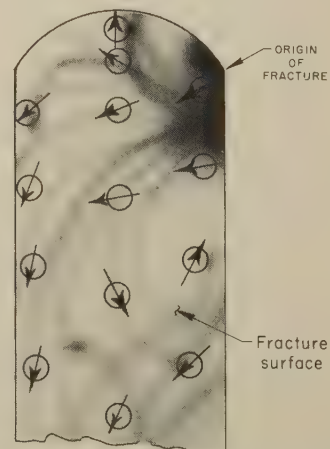
Arrows show the directions of crack propagation at various locations as indicated by the microscopic fracture marks observed. These combine to define fracture propagation paths and the location of the crack origin.

Fig. 29. Schematic representation of fractographic mapping of data obtained from examination under the microscope of a fracture that was featureless at low magnification

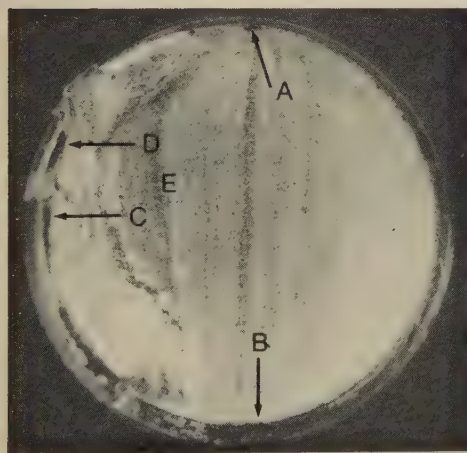
Light fractograph $2\frac{1}{2}\times$

Interpretation of the fracture surface indicates: (a) loading was mainly by unidirectional bending; (b) stress concentration was high (many closely spaced origins along thread root at right, between A and B, and leading crack edges); (c) small reversed bending load or backlash may have been present (secondary origins at C, D); and (d) nominal stress was low (small region of final, fast fracture at E).

Fig. 33. Fatigue fracture in a steel bolt

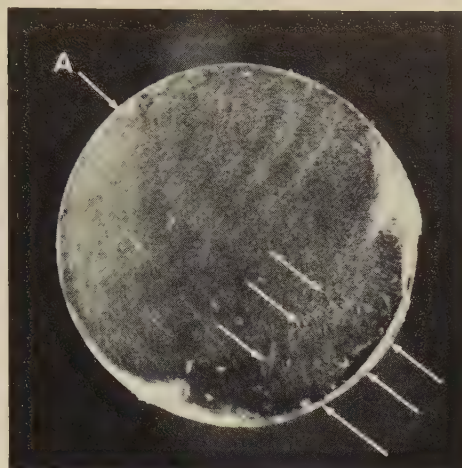
Light fractograph $3\times$

Interpretation of the fracture surface indicates: (a) the loading was rotating bending; (b) there was no marked stress concentration (single origin at A); and (c) the nominal stress was low (small region of final, fast fracture between sets of arrows).

Fig. 34. Fatigue fracture in a steel shaft

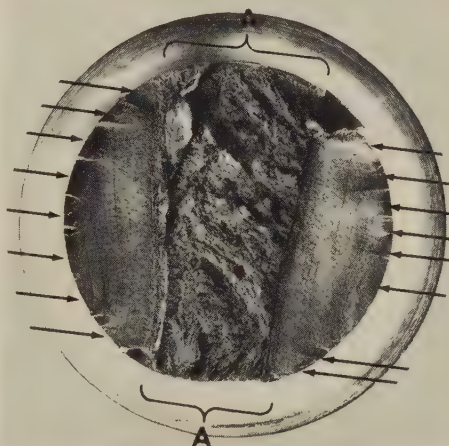
Light fractograph $0.9\times$

Interpretation of the fracture surface indicates: (a) loading was by reversed bending; (b) stress concentration was mild (several origins at arrows on both sides); and (c) nominal stress was moderate to high (fairly large region of final, fast fracture between brackets at A's).

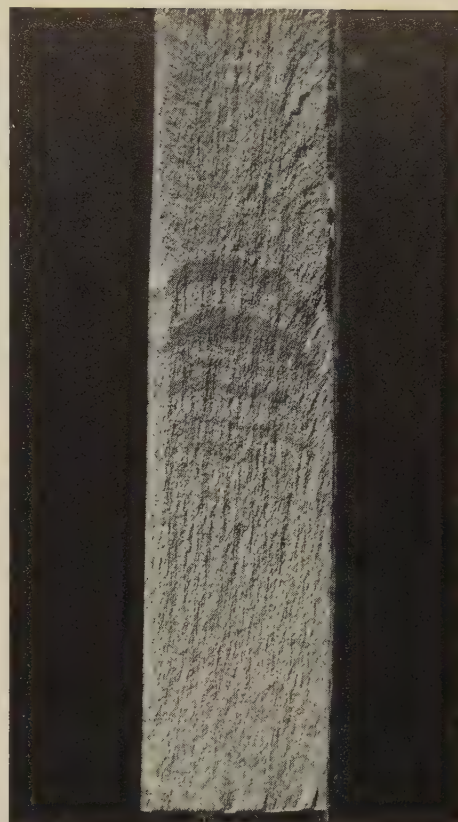
Light fractograph $1.6\times$

Fig. 36. Changes in mechanism of fatigue-fracture propagation in aluminum-clad aluminum alloy 7075-T6 plate. The fracture marks changed with changes in stress intensity as the crack moved toward the top.

propagation rate. At higher K values, fatigue is no longer the dominant feature, and tearing of the material becomes increasingly prevalent. Fracture changes of this kind are shown in Fig. 36.

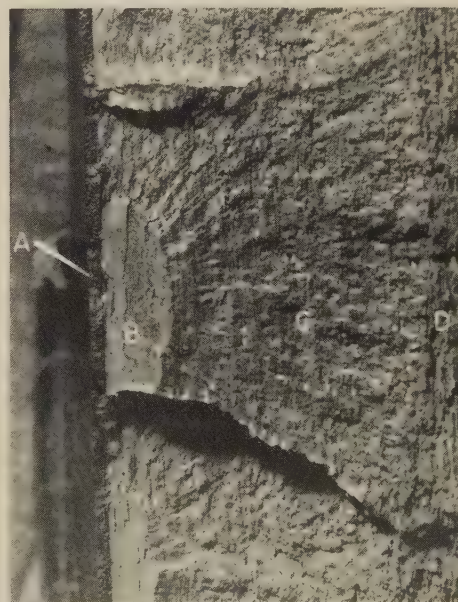
Light fractograph $5.7\times$

Small corrosion pits formed beneath the layer of chromium plate, as at A, and generated stress-corrosion cracks B. Growth of these cracks altered the stress intensity at the crack tips, leading to propagation of fatigue cracks C. Final, fast fracture D occurred when the critical crack-tip stress-intensity value was reached.

Fig. 37. Changes in fracture mechanism and appearance that were caused by changes in chemical and stress environment for a chromium-plated aluminum alloy 7079-T6 forging

Changes Caused by Altered Environments. A fracture-mechanism change as a result of different chemical and stress environmental conditions is shown in Fig. 37. A corrodent generated small pits below a layer of chromium plate and provided the environment for the growth of stress-corrosion cracks, which originated at the pits. The stress may have been residual or applied. As the stress-corrosion cracks grew, the stress intensity at the crack tip increased for the applied cyclic loads. At some critical level of environment and cyclic-stress intensity, the fracture mechanism changed to one of pure fatigue. The fatigue cracks propagated until the critical crack-tip stress-intensity

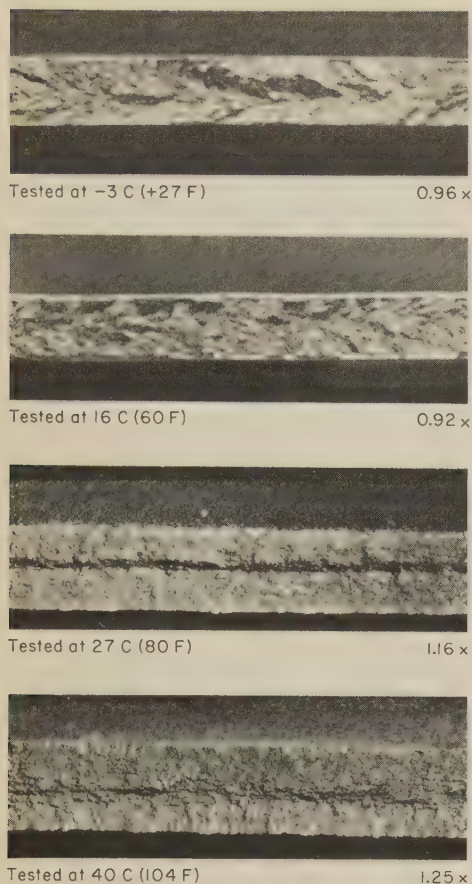
Light fractographs showing fracture surfaces of four sections cut from a single length of low-carbon steel pipe, which were burst by hydraulic pressure at the temperatures indicated. The steel had a yield strength of 414 MPa (60 ksi).

Fracture mechanism was changed by the test temperature, as attested by the chevron pattern with minute shear-lip zones at -3°C ($+27^{\circ}\text{F}$), by the chevron pattern with 15% shear-lip zone at 16°C (60°F), and by the 100% shear pattern at 27°C and 40°C (80 and 104°F).

Fig. 38. Transition of fracture appearance with changes in test temperature (Ref 9)

An example of the effect of temperature environment is provided in Fig. 38, which shows the surfaces of four fractures in carbon steel pipe (all from the same pipe length) obtained in tests at four different temperatures. The increase in test temperature caused an abrupt transition in fracture mechanism from a flat, high-velocity type with a chevron pattern at 16°C (60°F) and below, to full shear at 27°C (80°F) and higher.

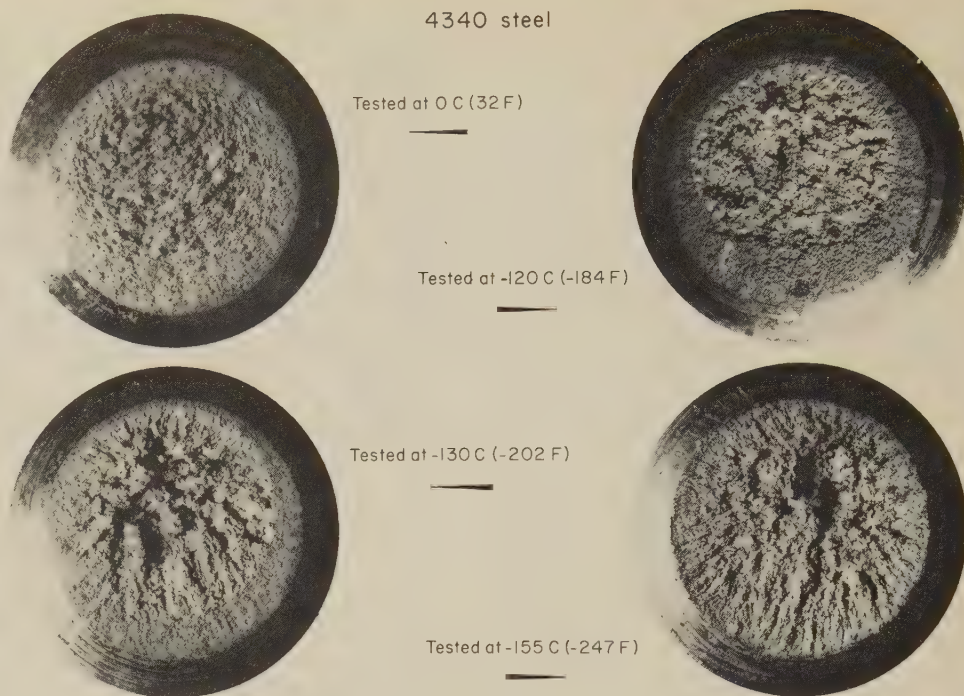
Specimens broke at the temperatures indicated. The radius at the root of the notch for each specimen was 0.001 in. Each of the fractures originated in the notch. The fracture at 0°C (32°F) is 100% fibrous with circumferential ridges. At -120°C (-184°F), the fibrous marks give way to an inner, circular zone of radial marks. At -130°C (-202°F), the radial zone is larger, and at -155°C (-247°F), a radial type of fracture has completely replaced the fibrous type.

Fig. 39. Fracture appearance as affected by test temperature, for four notched tension-overload fractures in 4340 steel (light fractographs, all at about $9\frac{1}{4}\times$)

Figure 39 presents another example of changes in fracture appearance caused by decreasing test temperatures, for sharply notched (root radius, 0.001 in.) tensile specimens. In this series, the circumferential fibrous ridges in the fracture at 0°C (32°F) were gradually replaced by a central zone (the last to fracture) of radial marks as the test temperature was lowered, until at -155°C (-247°F), the fracture was completely radial.

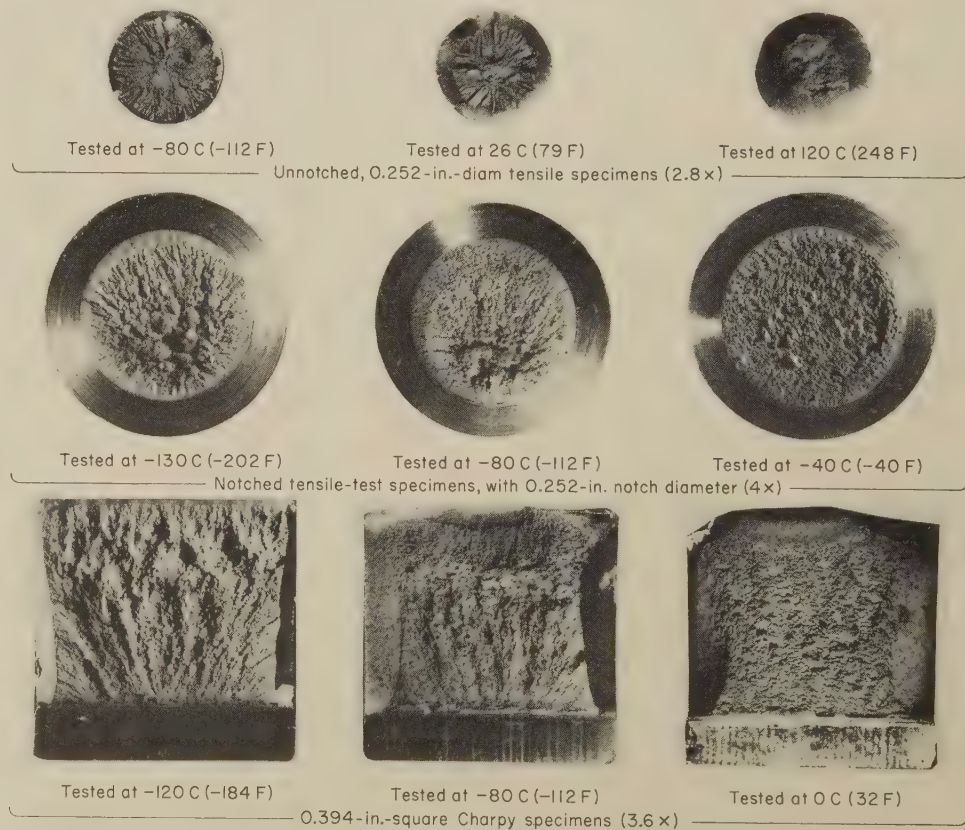
All specimens were cut from $\frac{1}{8}$ -in.-square 4340 steel bar stock, heat treated as follows: held 1 hr at 899°C (1650°F) and air cooled, held 1 hr at 843°C (1550°F) and oil quenched, then held 1 hr at 538°C (1000°F) and oil quenched. Specimens of all three

types show the same transition with increasing test temperature, from completely radial marks to mixed radial and fibrous marks to circumferential fibrous ridges. The only difference is in the temperature at which the transition is complete.

Fig. 40. Light fractographs showing effect of test temperature on fracture appearance, for three types of 4340 steel test specimens (Ref 10)

This same behavior is reflected in Fig. 40 for three types of test specimens that were fractured at three selected temperatures. The change from the radial fractures obtained at the lowest temperature of each series to the circumferential fibrous ridges in the highest-temperature fracture in each series is clearly evident.

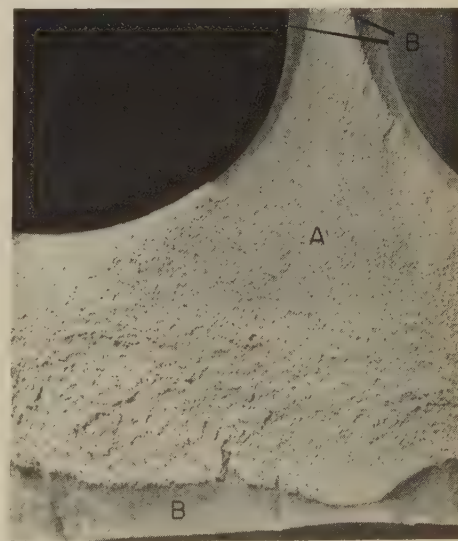
Light fractograph $1.1\times$
Flat region A is normal to the principal stress axis and was formed by plane-strain fracture. The shear lips, B, were the result of plane-stress fracture.

Fig. 42. Two distinctly different types of fracture regions in an aluminum alloy 7075-T6 forging

mal to the primary stress direction, and (b) a region of inclined fracture (the shear-lip zone). The first region is the result of plane-strain fracture, the second of plane-stress fracture. These fracture regions are shown in Fig. 42.

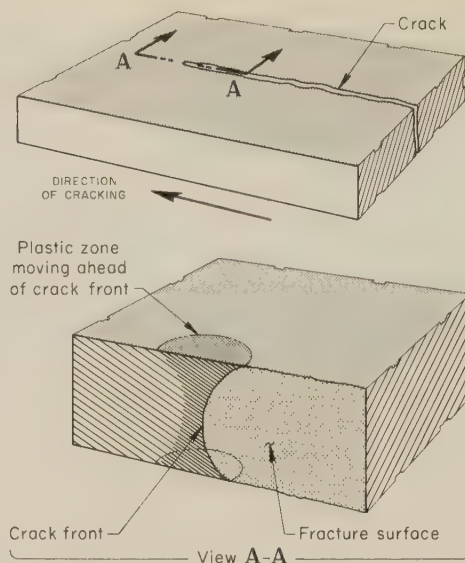
Fig. 43. Plastic zone at the crack tip of a thin sheet. Here, the fracture is usually completely in the plane-stress mode. (Derived from Ref 11)

Plane-strain fracture occurs in thick sections and in notched members. Plane-stress fracture occurs when the fracture intersects any unnotched free surface; its extent is governed by the plastic-deformation characteristics of the metal. Thin sheets of a ductile metal characteristically fracture completely in the plane-stress manner. This feature is related to the size of the plastic zone at the crack tip. Figure 43 is a schematic representation of the location of this plastic zone.

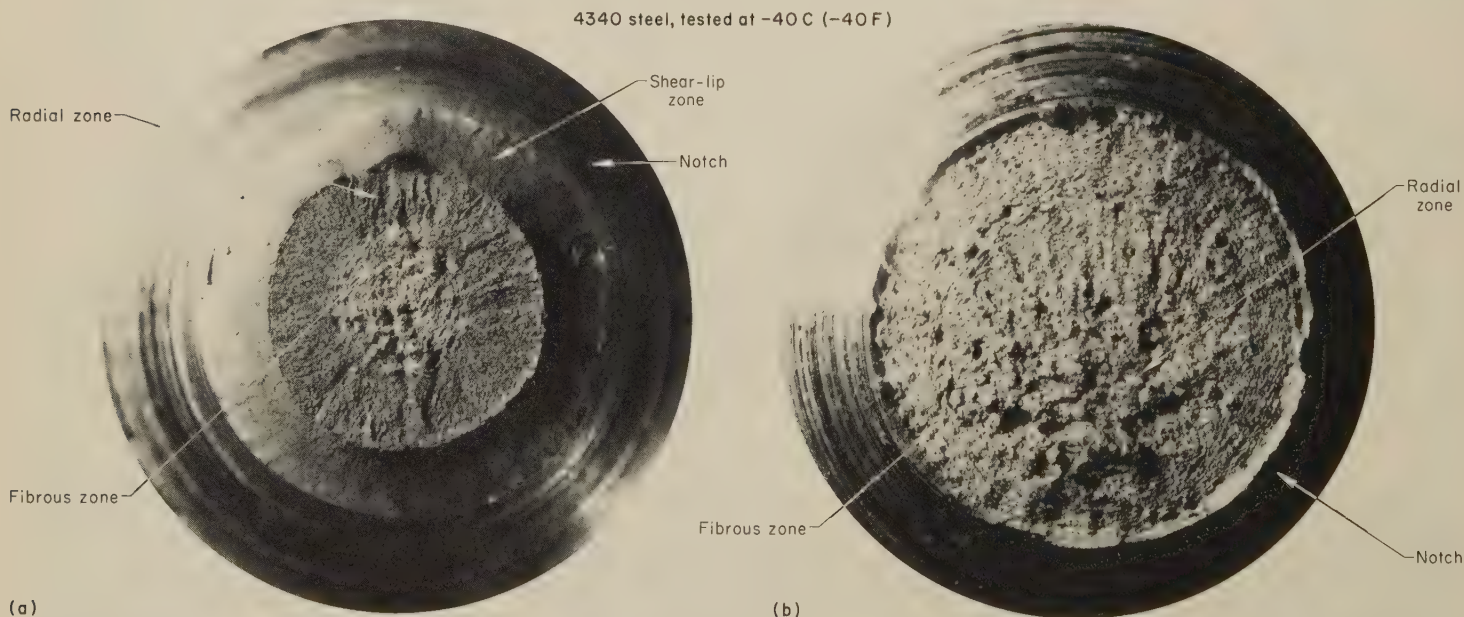
Fractographs show notched 4340 steel specimens, with two different notch-root radii, tested in tension overload at -40°C (-40°F). Room-temperature tensile strength was 1151 MPa (167 ksi).

(a) Notch-root radius of 0.1 in. produced a normal tensile fracture having a central fibrous zone, a surrounding radial zone, and an outer shear-lip zone of

final, fast fracture. The notched tensile strength of this specimen was 1544 MPa (224 ksi). (b) Notch-root radius of 0.01 in. altered the stress state, caused the fracture to initiate in the notch, and produced an initial ring of fibrous circumferential ridges and a central radial zone. The notched tensile strength of this specimen was 1758 MPa (255 ksi).

Fig. 44. Change in fracture appearance effected by change of notch-root radius

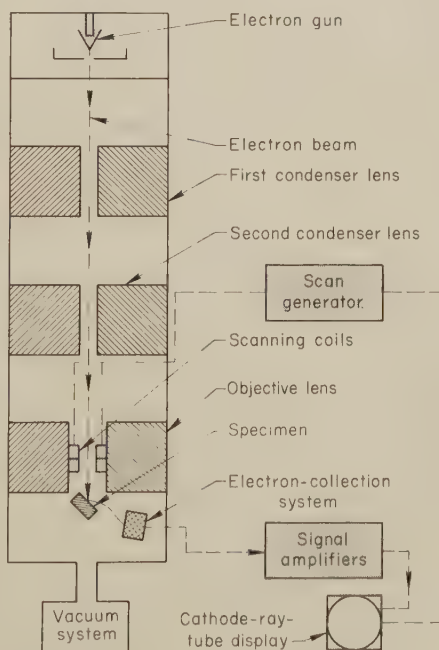
Fig. 1. Essential components of a scanning electron microscope (Ref 15)

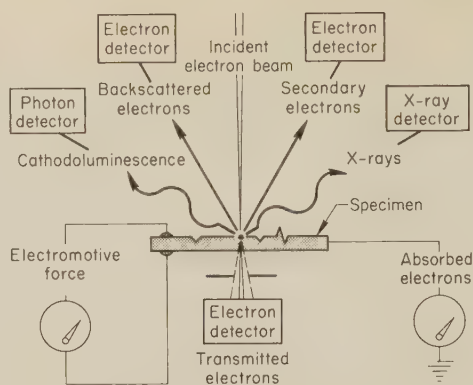
Fig. 2. Useful signals generated by an electron beam (Ref 16)

Modes of Operation. Figure 2 shows the useful signals generated by the various interactions of the incident electron beam with the specimen, and the devices used to detect or collect the signals. Although both secondary and backscattered electrons are used for fractography, the secondary electrons are almost always the preferred signal because they offer better resolution, produce an abundant signal, and permit viewing of areas of the specimen that are not in a direct line of sight with the collector. There are occasions, however, where it is necessary to sacrifice resolution in order to improve image contrast, especially with smooth specimens and at low magnifications.

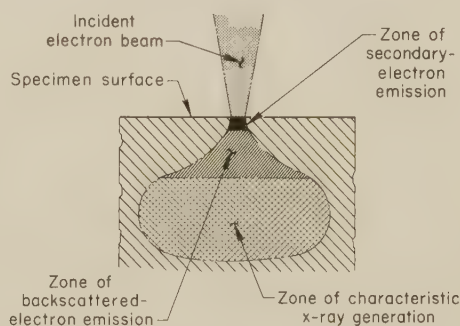
Fig. 3. Pattern of zones in a specimen that are sources of signals generated by an incident electron beam

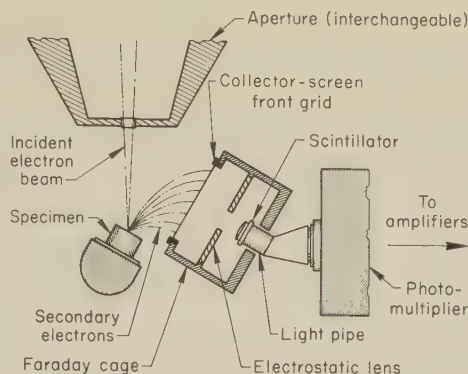
Fig. 4. A typical secondary-electron collector (Ref 17)

plied to the collector. A typical secondary-electron collector is shown in Fig. 4. It consists of a Faraday cage (defined as a grounded metallic screen completely surrounding a space to protect that space from external electrostatic influences) with a large-mesh collector-screen front grid to which a bias potential of between +250 and -30 volts is applied. A positive voltage attracts the low-energy (low-velocity) secondary electrons but does not deflect the high-energy (high-velocity) backscattered electrons, which continue to move in straight lines from their points of emergence from the specimen surface. By adjusting the bias voltage upward, a greater proportion of secondary electrons is captured. If the bias voltage is made negative, the secondary electrons are repelled and the electrons captured will be essentially of the backscattered type. A minimum collection of backscattered electrons can be achieved by tilting the collector to an angle at which the straight-line path of such electrons will miss the aperture of the electrostatic lens inside.

The electrons that pass through the collector-screen front grid are accelerated by the electrostatic lens to make impact on a disk of scintillating material with sufficient energy to produce light. The light pipe (or light guide) attached to the scintillator permits light-signal transmission without electrical noise to a photomultiplier, which produces the electric signal used to modulate the brightness of the cathode-ray tube. Although the secondary-electron collector may also be used for collecting backscattered electrons by removing or reversing the bias potential of the grid, it is frequently more effective to provide separate collectors so that each collector can be most favorably positioned.

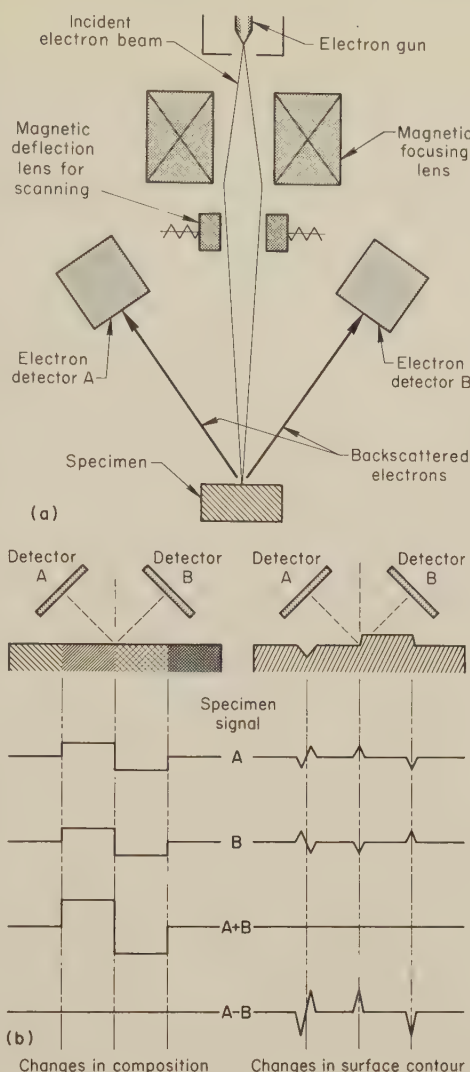
The detectors are symmetrically placed as shown in (a) for the determination of topographic features and chemical elements in the specimen surface. The backscattered-electron signals are added and subtracted, as shown schematically in (b), for individual viewing of the changes in composition and changes in surface contour.

Fig. 5. Detector arrangement and signal representation for a solid-pair detector

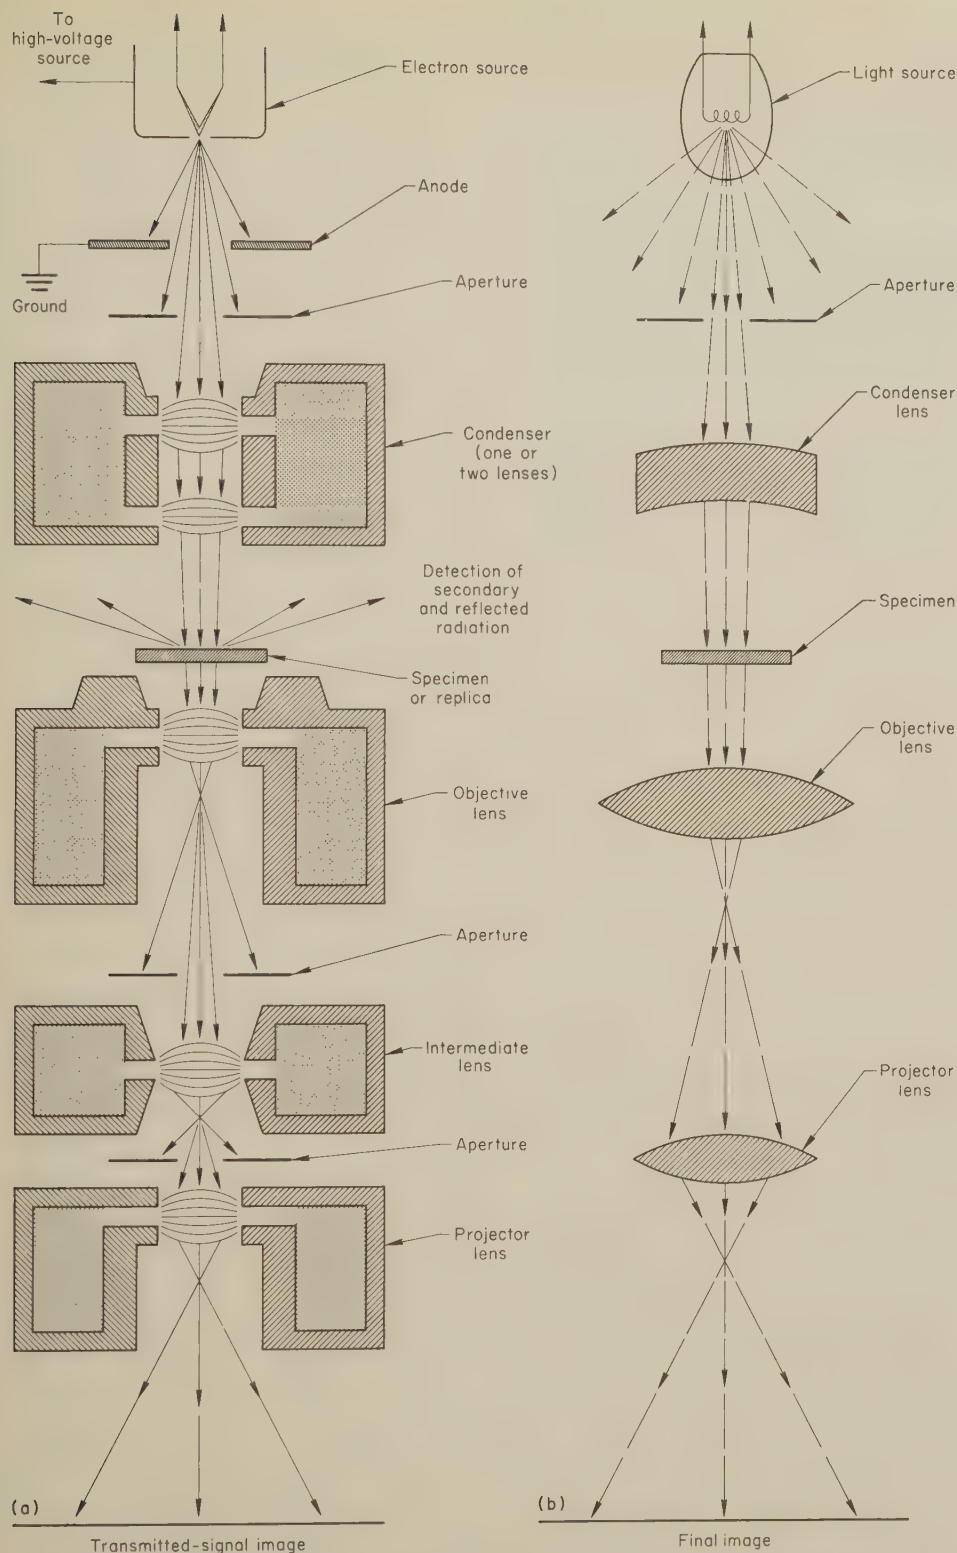
Fig. 1. Schematic representation comparing basic components of (a) a transmission electron microscope (TEM) and (b) a light microscope

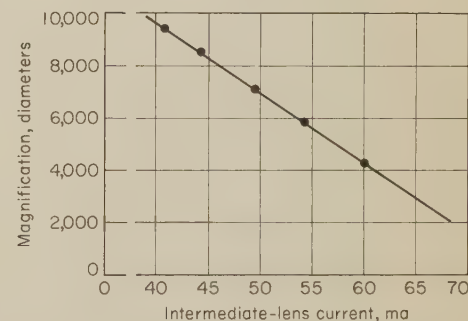
Fig. 2. Typical magnification-calibration curve for a transmission electron microscope. Magnification is measured from a replica grid and is plotted against the current settings of the intermediate lens.

using replicas with standard grids. These are available from companies dealing in electron-microscope supplies. The replica grids are made to a known number of grid lines per unit length (75 to 200), and therefore it is possible to determine the linear image magnification of a test photograph. If the amperage of the electrical current through the coils of the intermediate (or other reference) lens is

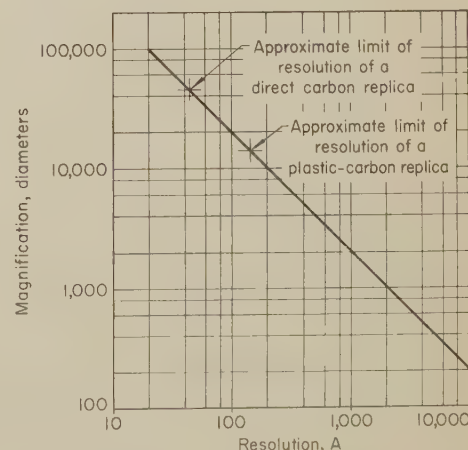
Fig. 3. Relation between resolution and the magnification required for the eye to perceive this resolution

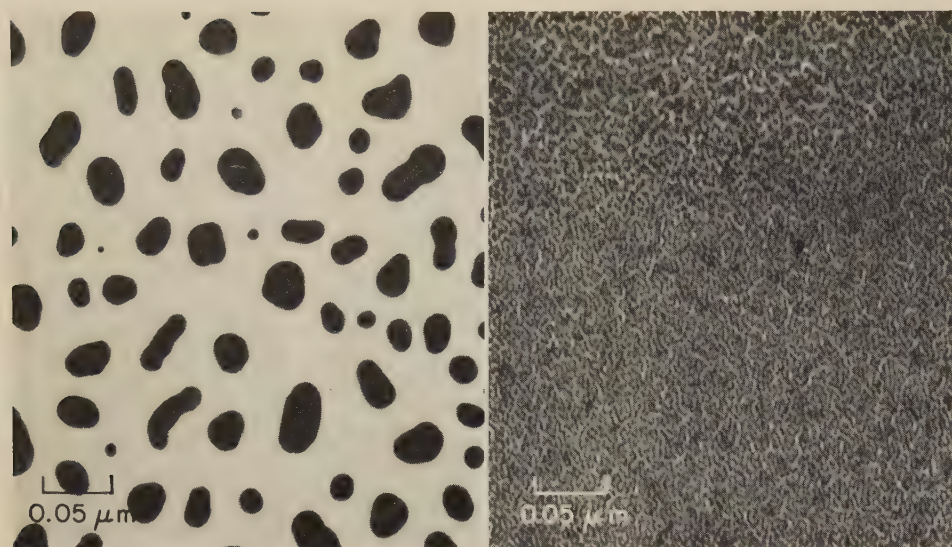
TEM micrograph (carbon replica) 180,000× TEM micrograph (carbon replica) 190,000×
 Fig. 4. Comparison of aggregate size in vapor-deposited coatings of gold (micrograph at left) and palladium (micrograph at right). Mean thickness of coatings was 30 Å.

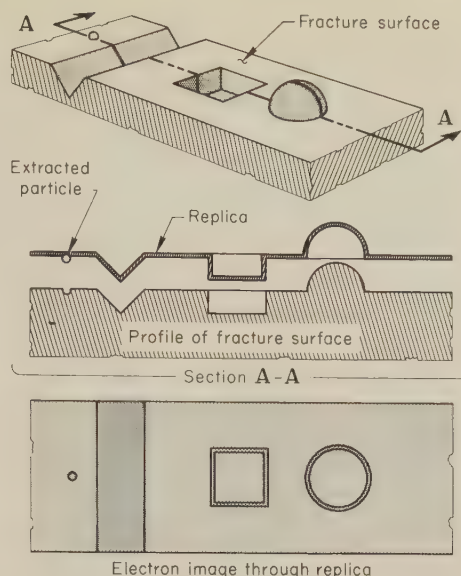
Fig. 5. Schematic views illustrating the single-stage replication technique

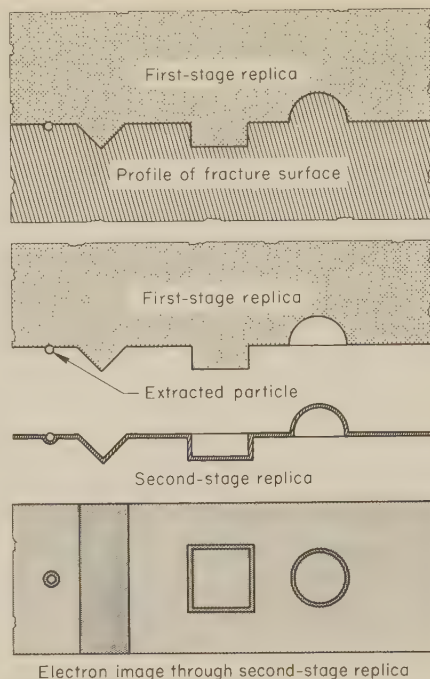
Fig. 6. Schematic views illustrating the two-stage replication technique

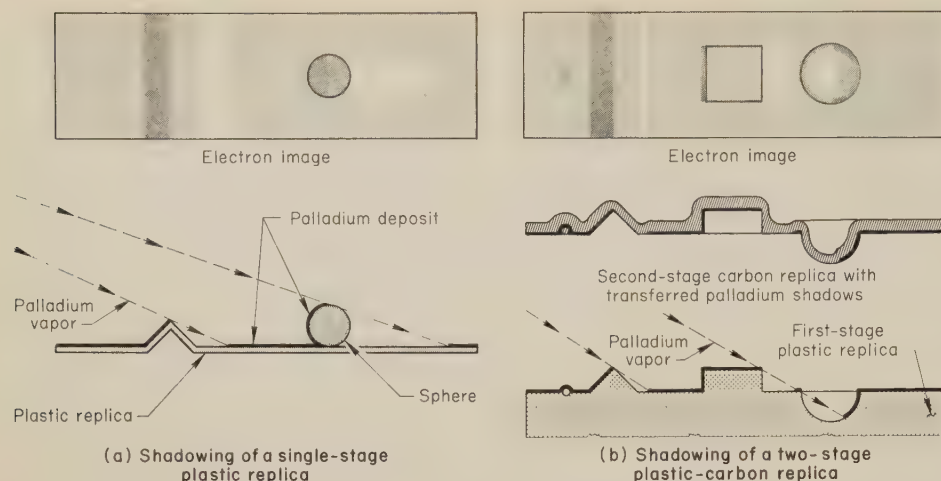
Fig. 7. Shadowing processes for single-stage plastic replicas (a) and two-stage plastic-carbon replicas (b). A sphere of known size can be placed on a replica, as in (a), to calibrate shadow length.

When viewing a fractograph of a shadowed replica, it should be remembered that the dark portions in the print represent regions where the shadowing layer is thick, and shadows on the print represent regions where less shadowing metal was deposited. Because shadowing metal will not deposit in thick layers at the bottoms of depressions, it can be deduced that features that appear as light regions were depressions in the surface.

If the shadowing metal is deposited directly on the fracture surface, as in single-stage direct carbon replicas, a light region observed in the replica was a depression on the fracture surface. On the other hand, if the shadowing metal is deposited on a thick first-stage plastic replica, a light region inside a feature on a second-stage carbon replica shows that it was a hill on the actual fracture surface. For this reason, sound interpretation of a fractograph depends on knowing the replication procedure used.

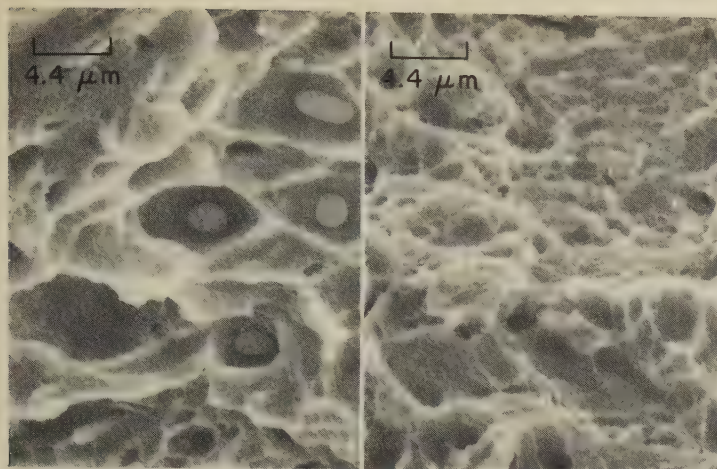
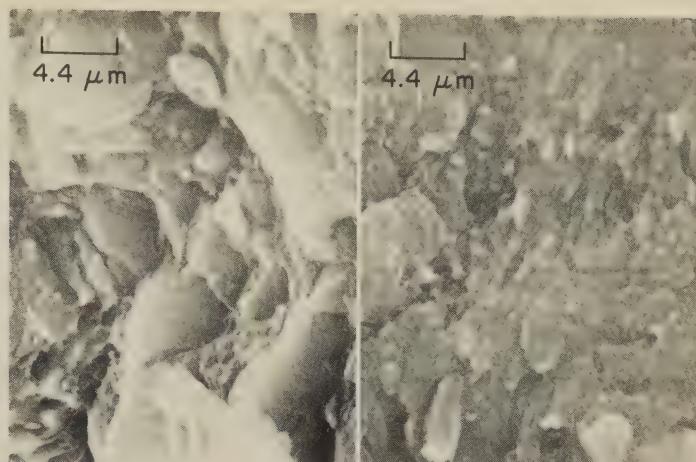
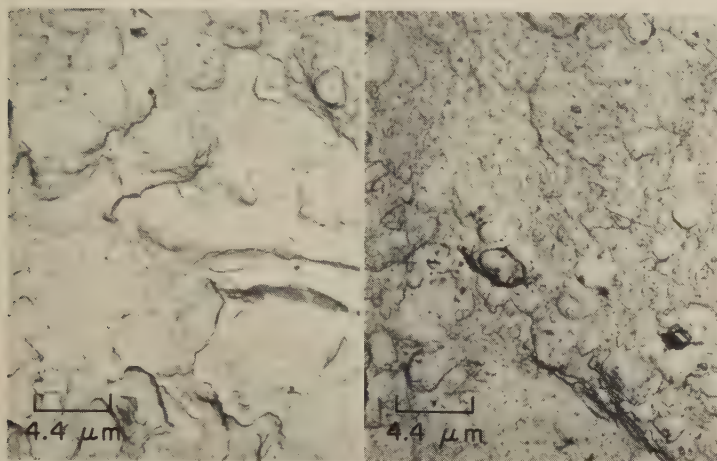
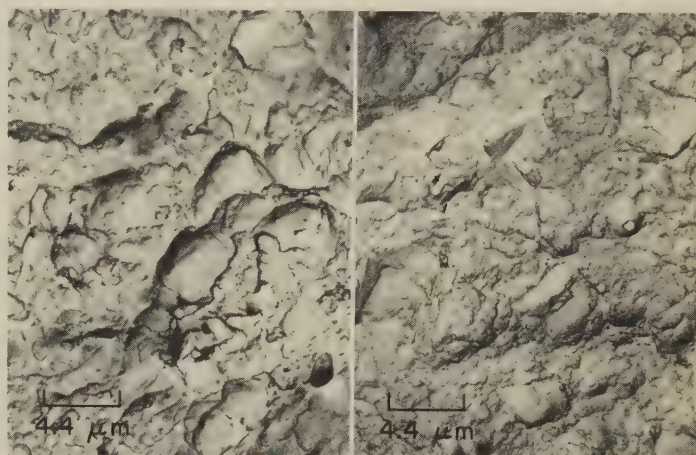
SEM fractographs taken directly from the fracture surface; 2250 \times

SEM fractographs of a thick, single-stage, gold-coated plastic replica; 2250 \times

TEM fractographs of a two-stage, unshadowed, plastic-carbon replica; 2250 \times

TEM fractographs of a two-stage, chromium-shadowed (at 50°), plastic-carbon replica; 2250 \times

Fig. 8. Comparison of the appearance of dimples in a fracture surface as seen in an SEM direct fractograph and in SEM and TEM fractographs of different types of replicas. The fractographs are of a Charpy V-notch impact specimen of vanadium-modified 4335 steel. Each pair of fractographs shows two areas near the root of the notch that exhibit dimples of different sizes.

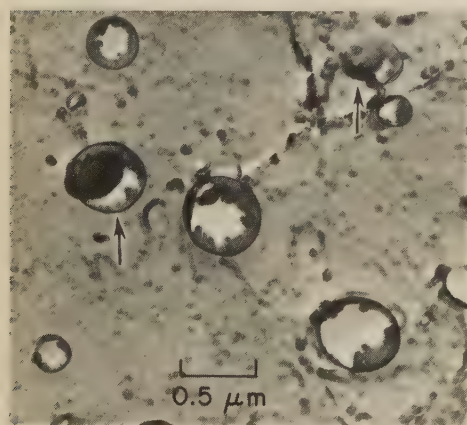
TEM fractograph (p-c replica)

20,000×

The thin film of plastic between the bubble and the replicated surface is seen to be partly removed from the plastic replica at the bubbles indicated by arrows. It evidently adhered to the fracture surface at the other bubbles.

Fig. 10. Bubble artifacts caused by an excess of solvent (acetone) in the cellulose acetate used to make a plastic replica

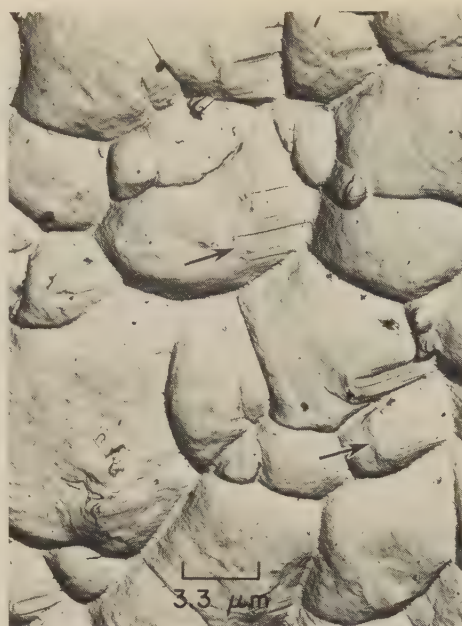
TEM fractograph (p-c replica)

3000×

Fig. 11. Scraping artifacts (as at arrows), which resemble linear striations, on the sides of dimples

feature, such as is shown in the lower half of Fig. 9. Another common artifact develops when the plastic scrapes against the fracture surface as it is pulled off. This gives rise to linear marks such as those indicated by arrows in Fig. 11. These linear marks usually occur at several neighboring features. When viewed in stereo, they are seen to be on the sides of hills on the replica (all on one side or the other, depending on the direction of stripping and scraping). This type of replica

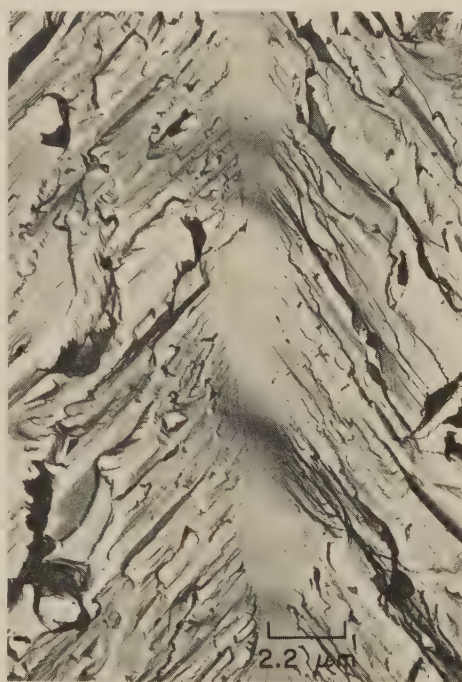
TEM fractograph (p-c replica)

4500×

Fig. 12. Distortion artifact at the {100} cleavage plane (narrow central strip) in tungsten. This plane was originally flat but became distorted as the replica dried, giving the undulating appearance.

is a complicated procedure. The smoother the surface, the less damage occurs in drying. Replicas of flat fatigue-fracture surfaces and of the intergranular surfaces of fine-grained metals are barely affected, whereas replicas of irregular cleavage-fracture surfaces and surfaces including large ridges and valleys undergo severe distortion. Sometimes, slight distortions are noted. In the fracture in tungsten shown in Fig. 12, the {100} cleavage plane, which was originally flat, has an undulating appearance.

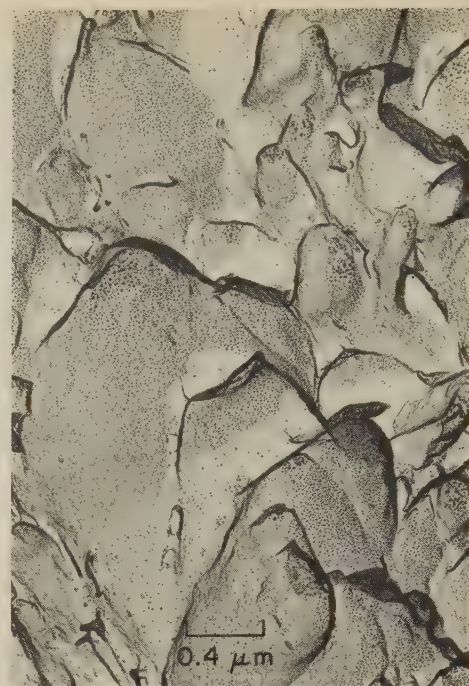
TEM fractograph (p-c replica)

22,500×

Fig. 13. Palladium-shadowed replica of a fracture in nickel showing reticulated shadowing metal on dimples. Reticulation was caused by the melting of the shadowing metal in the microscope and the formation of globules.

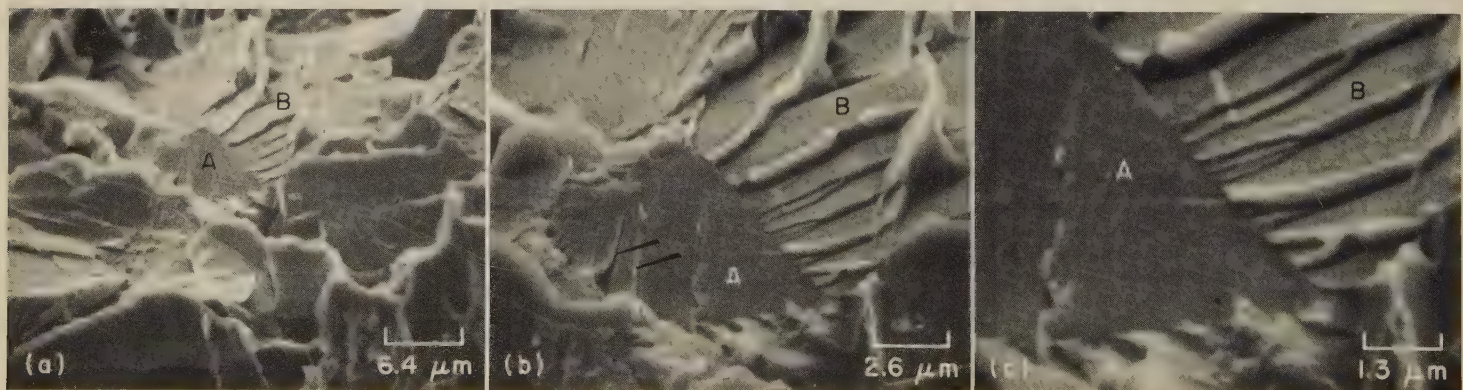
SEM fractographs

The specimen was tilted in the scanning electron microscope at an angle of 40° to the electron beam. The cleavage planes followed by the crack show various alignments, as influenced by the orientations of the individual grains. Grain A, at the center in fractograph (a), shows two sets of tongues (see arrowheads in fractograph b) as the result of local cleavage along the {112} planes of

microtwins created by plastic deformation at the tip of the main crack on {100} planes. Grain B and many other facets show the cleavage steps of river patterns. The junctions of the steps point in the direction of crack propagation from grain A through grain B, at an angle of about 22° to the horizontal plane. The details of these forks are clear in fractograph (c). See also Fig. 2 and 3.

Fig. 1. Cleavage fracture in a notched impact specimen of hot rolled 1040 steel broken at -196 C (-321 F), shown at three magnifications

Figure 1 provides three views, at increasing magnification, of an area in an impact fracture exhibiting features that are typical of cleavage. It is apparent that the fracture plane changes orientation from grain to grain. As a result, the average grain size can be measured on the fractograph and related to grain-size measurements on a metallographic section. The change of orientation from grain to grain leads to a branching of the crack along different planes and to a very chaotic over-all appearance of the fracture surface. At higher magnification, however, many features typical of cleavage can be identified. In Fig. 1(b), the evidence of change in orientation between

grain A and grain B is particularly clear because of the river patterns that begin in grain B at the interface. The river patterns, which represent steps between different local cleavage facets of the same general cleavage plane, are well defined. They run from left to right. River-pattern steps are usually the result of cleavage along second-order cleavage planes and, to minimize the energy of fracture, they join like river tributaries in the direction of crack propagation. Thus, by following a river pattern, it is possible to determine the direction of crack propagation. The height of river-pattern steps is further related to the angle between the tensile-stress axis and the orientation of the cleavage plane within a particular grain. A grain that has no, or few, river patterns may have been oriented at a right angle to the main tensile axis, causing the fracture to propagate very easily on a single plane. River patterns are modified by the presence of inclusions and precipitates.

Tongues and Microtwins. A second feature of cleavage fracture, found very often in iron and low-carbon steel, is referred to as a "tongue". Tongues appear on cleavage facets as very fine slivers of metal (see arrowheads on grain A in Fig. 1; for further detail, see grain A in Fig. 2). These minute slivers of metal are usually aligned along well-defined crystallographic directions. It has been shown that such features result from cleavage across microtwins formed by plastic deformation at the tip of the main propagating crack. The plane of the microtwins is a $\{112\}$ plane making an angle of 35° with the $\{100\}$ cleavage plane of the main fracture path. Thus, by tilting and rotating the specimen, it is possible to measure this angle and also to align the specimen so that the cleavage facet is at a right angle to the incident electron beam. The intersection between the main cleavage plane and the tongue is along a $[110]$ direction. By measuring the angle between the different $[110]$ traces, the exact angle between the cleavage plane and the electron-beam axis can be determined.
